**CLOSURE REPORT
TEMPORARY ACCUMULATION AREA (TAA) 651A
MARINE CORPS AIR STATION
EL TORO, CALIFORNIA**

**Environmental Remedial Action
Contract No. N62474-98-D-2076
Contract Task Order 0024**

**Document Control Number 5222
Revision 0**

January 7, 2003

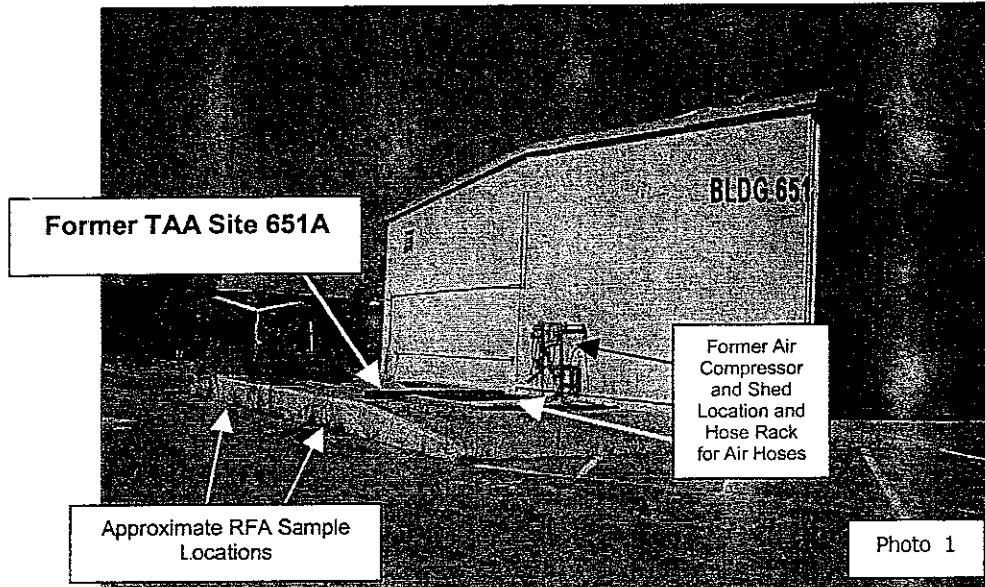
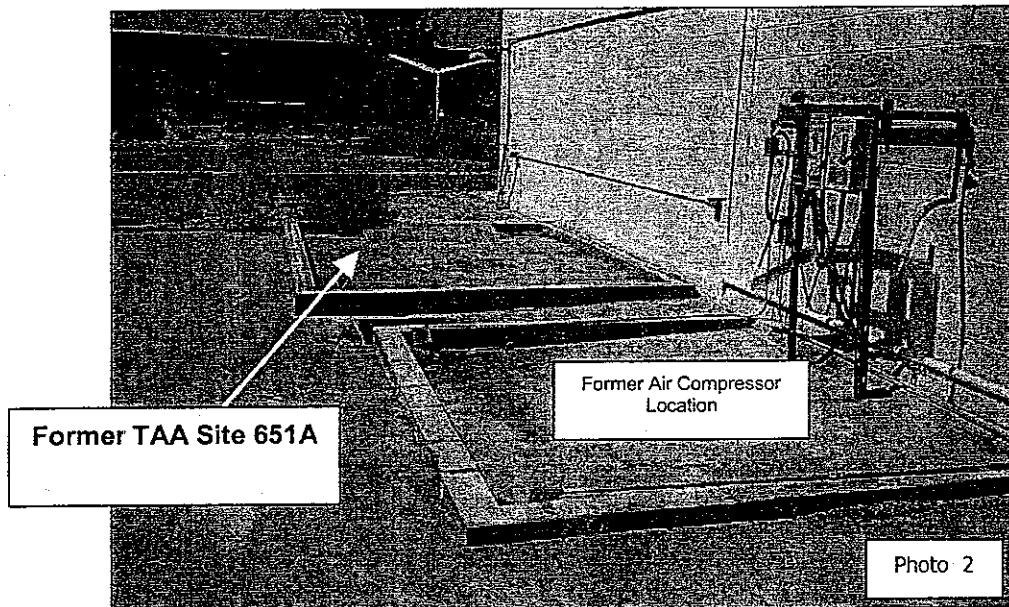
Photographs 1 and 2. Former Temporary Accumulation Area (TAA) 651A
Also Known As Solid Waste Management Unit (SWMU) 165
And Former Wash Rack (SWMU 164)
Marine Corps Air Station, El Toro

significant release from SWMU 164, and SWMU 164 coincides with the location of Former TAA Site 651A. Additionally, no stains or evidence of deteriorated pavement were observed during the visual inspection of 27 August 2001.

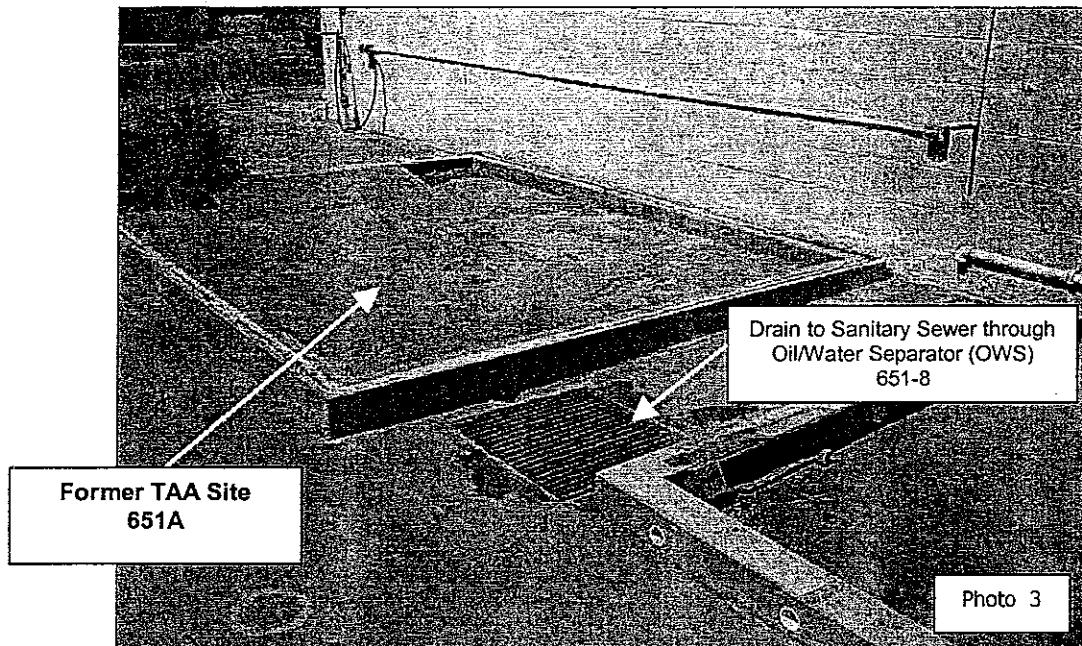
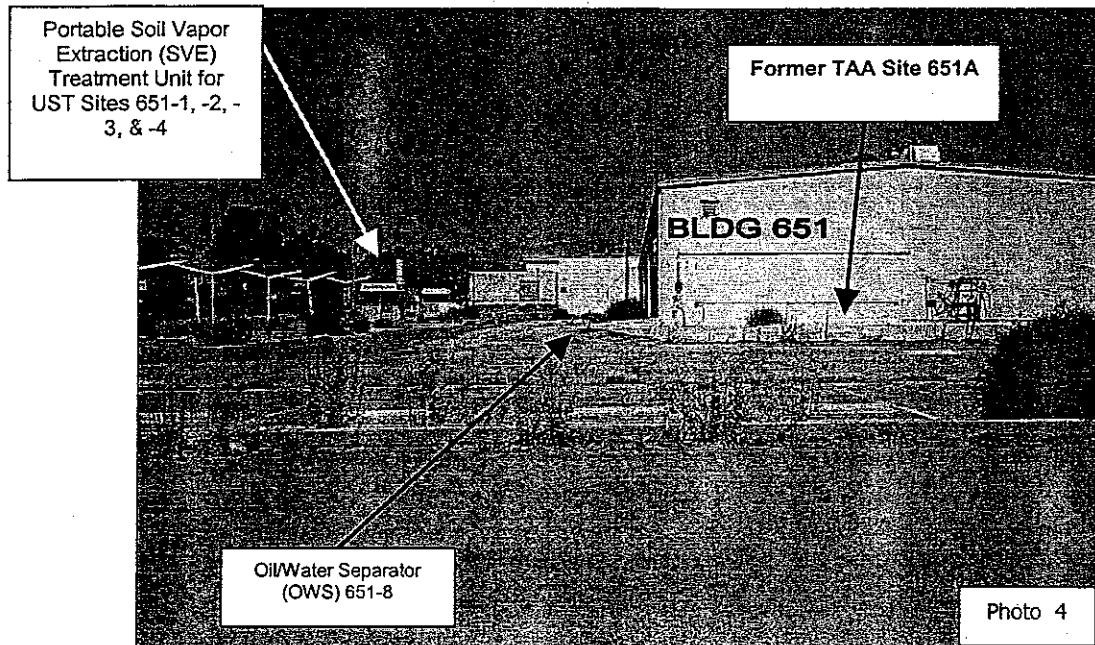
Photographs 3 and 4. Former Temporary Accumulation Area (TAA) 651A
Marine Corps Air Station, El Toro

The loading dock has two rectangular areas, each surrounded by concrete berms, approximately 6 inches high. The metal sheds were located within the bermed areas. The berms were in excellent condition and no cracks were observed in the berms during recent visual inspections.

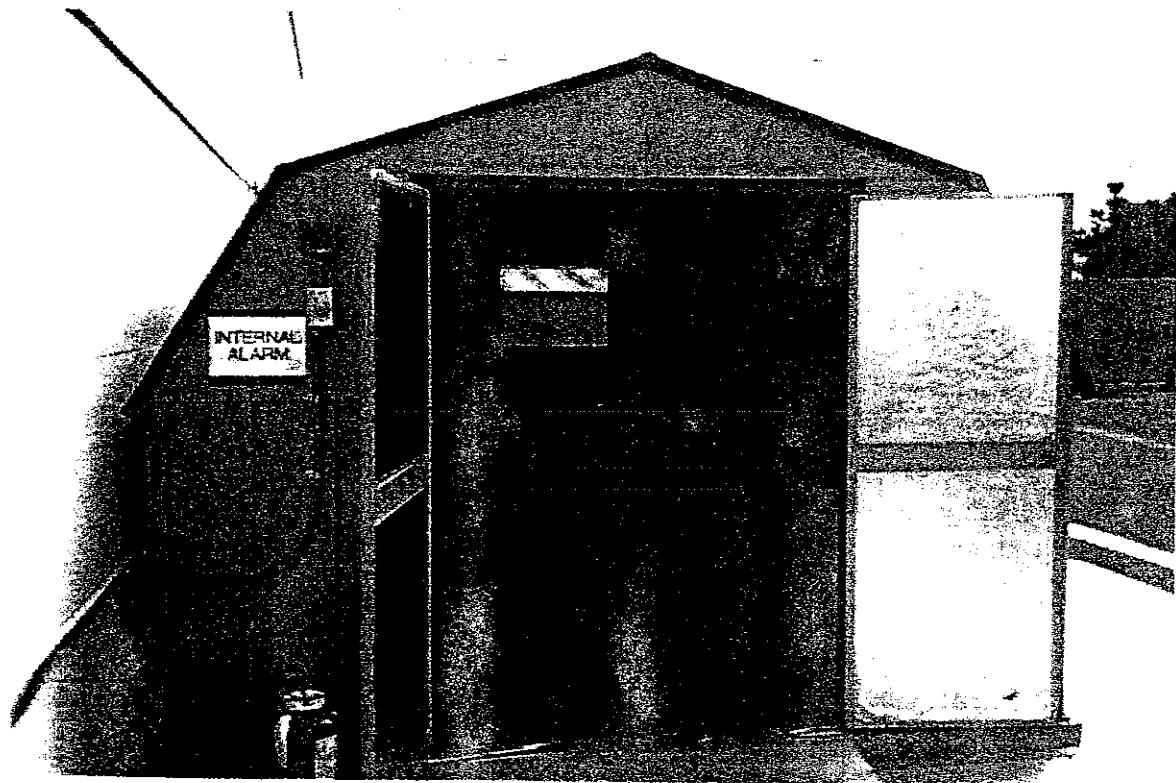
Bldg 651 ←

Morale, Welfare & Recreation Department (MWR), Auto #1

Building 651 - Exchange Auto Repair Station/Exchange Supplemental Gas Station - MWR-Ret This facility encompasses general personal vehicle maintenance and a gasoline filling station. Potential pollutants included gasoline motor fuel, oil, solvents and flammable liquid. There are 3 floor drains inside the building which drain to an oil/water separator (#651/652) which discharges to the sanitary sewer. Floors are cleaned with soap and water. A covered exterior hazardous waste storage shed is located at the site, however, it does not provide secondary containment. A spill cleanup kit and a SPCCP are present and personnel have been trained in spill cleanup and countermeasure activities.

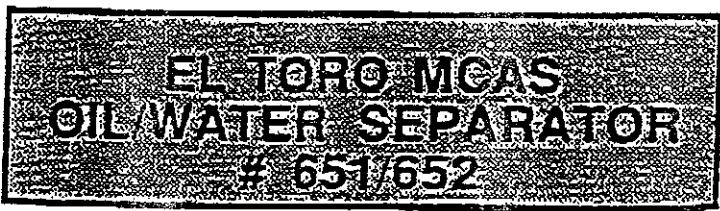
FIGURE 17.1

TO
SEWER

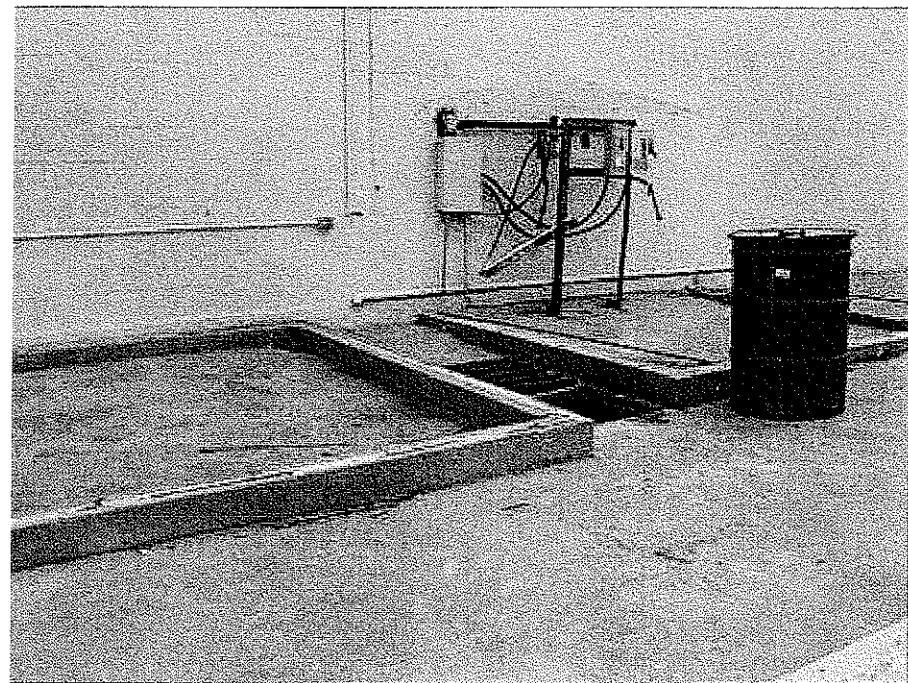
TAA 651A and Building 651.

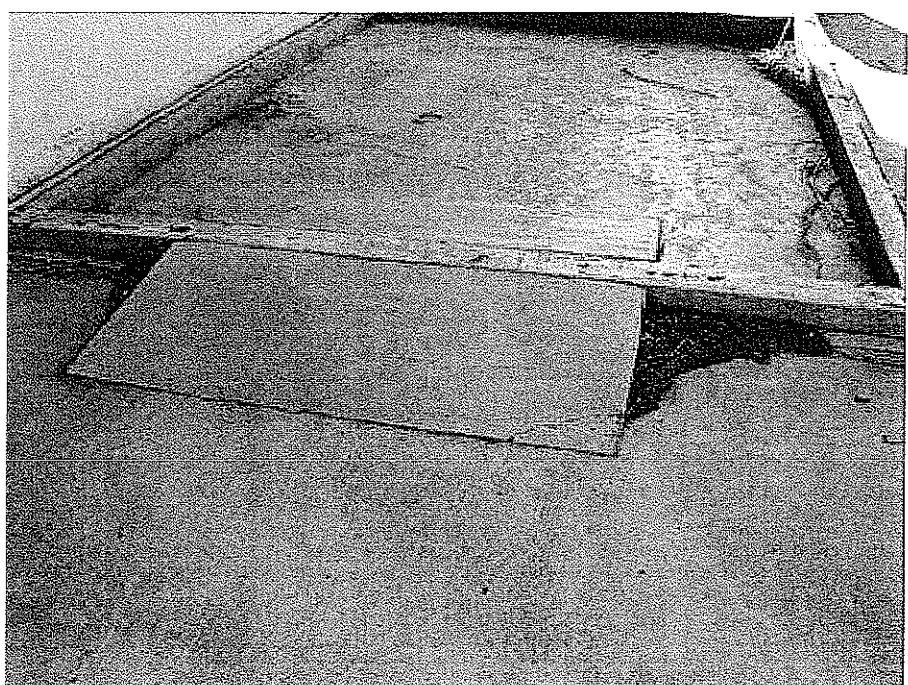
TAA 651A with ramp.

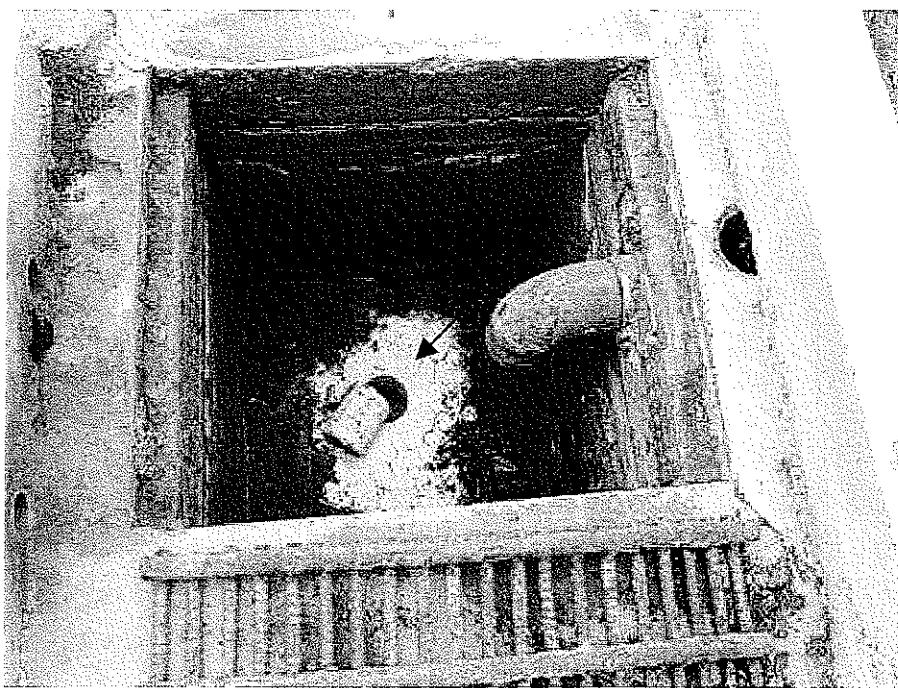
TAA 651A sump, with sample location

- During a site visit at TAA 651A site in August and September 2002, representatives from SWDIV, Station, IT, and the DTSC visually inspected the bottom of the drain sump located in the middle of the loading dock. Concrete sump was blind with no signs of any cracks, stains, or spills. During the inspection the Navy agreed to collect samples beneath or near the sump.
